GIS Evaluation of the Impacts on the Built and the 'Natural' Environment of the 11 March 2011 Tsunami in Rikuzentakata, Iwate Prefecture, Japan

Christopher Gomez, Patrick Wassmer, Claire Kain, Marie de Villiers, Kelli Campbell, Stephen Ward, Arash Moghaddam

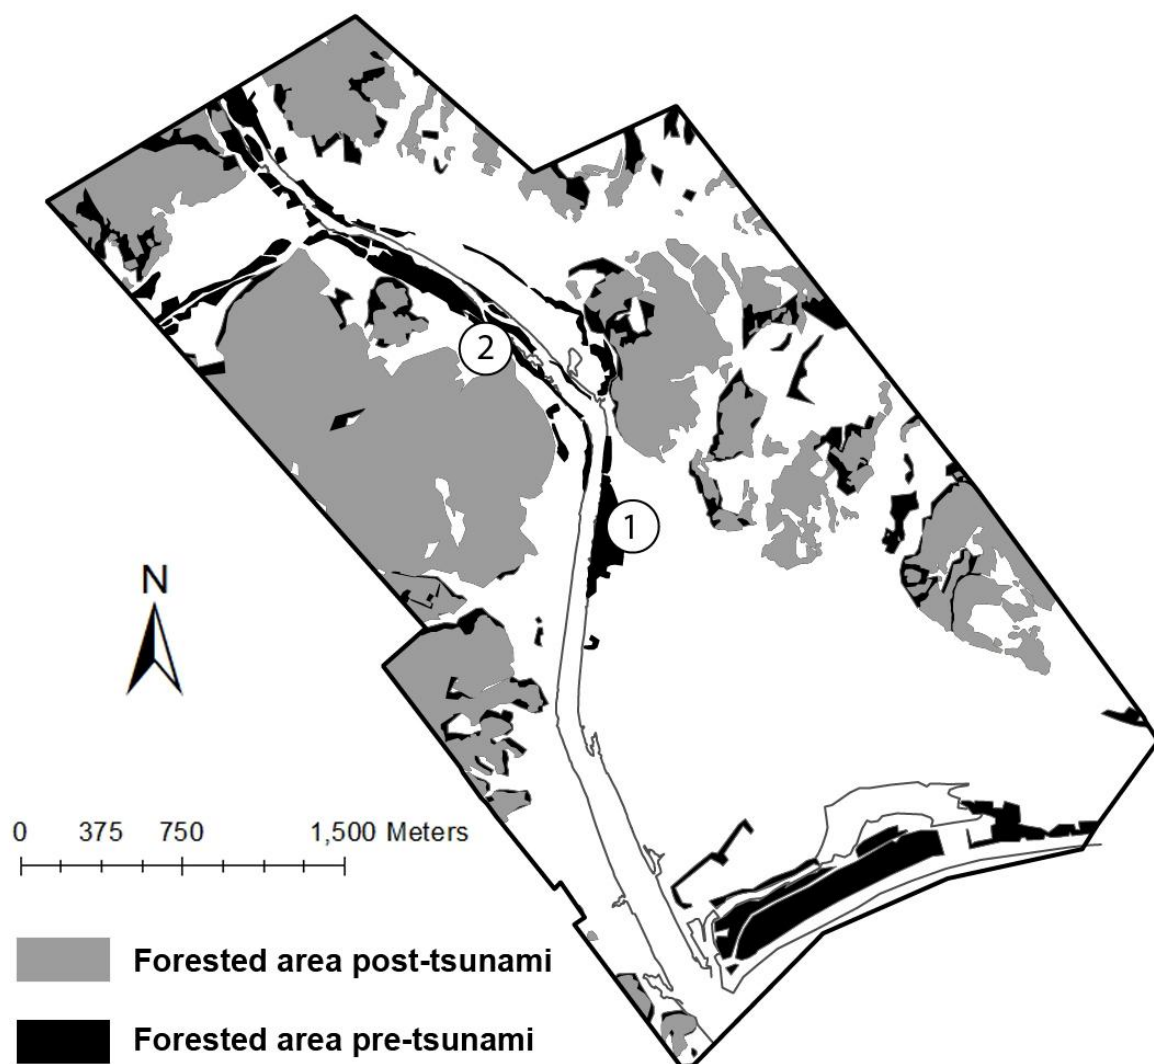
Along the 4.8 km of the Kesen River, all riparian trees have been uprooted and transported or flattened down by the tsunami. The loss of riparian forested area has been 0.29 km² along the Kesen river and 0.34 km² along the Kesen River and its tributary. The tsunami has destroyed both large and small clusters of forested land. The largest of these is 51,000 m², located between 3 km and 3.8 km from the mouth of the Kesen River. Destruction extends laterally

195 m from the closest bank and 250 m to the active channel central line. The largest area of flattened trees (1 on Fig. 7) measures 42,000 m². It is located on a left pointbar, along the Kesen River, only 2.5 km from the river mouth. The second area, where trees have been flattened is located on a right bar (2 on Fig. 7). It is 5,500 m² and it is located 3.6 km from the river mouth.

Because of the physical destruction of the lagoon's barrier, forested land in the area subsequently disappeared as well. This forested area was composed of two curtains of vegetation located on one or both sides of the lagoon with one interruption (Fig. 7). The total loss of forested area is 0.26 km², which is a 100% lost, except for one of the pine-tree. Only 66,000 m² of the land that hosted this forested area hasn't been colonized by sea-water, and 38,000 m² of this land is located at the back of the lagoon in an area that was protected by a stopbank and around the high-school ground.

Fig. 7 Impacts of the tsunami on forested areas in the municipality of Rikuzentakata; (1) and (2) are areas where the trees has been flattened down.
